Town of Shandaken, New York

# Repetitive Loss Area Analysis DRAFT

5-Year Update

# Town of Shandaken Repetitive Loss Area Analysis 5-Year Update

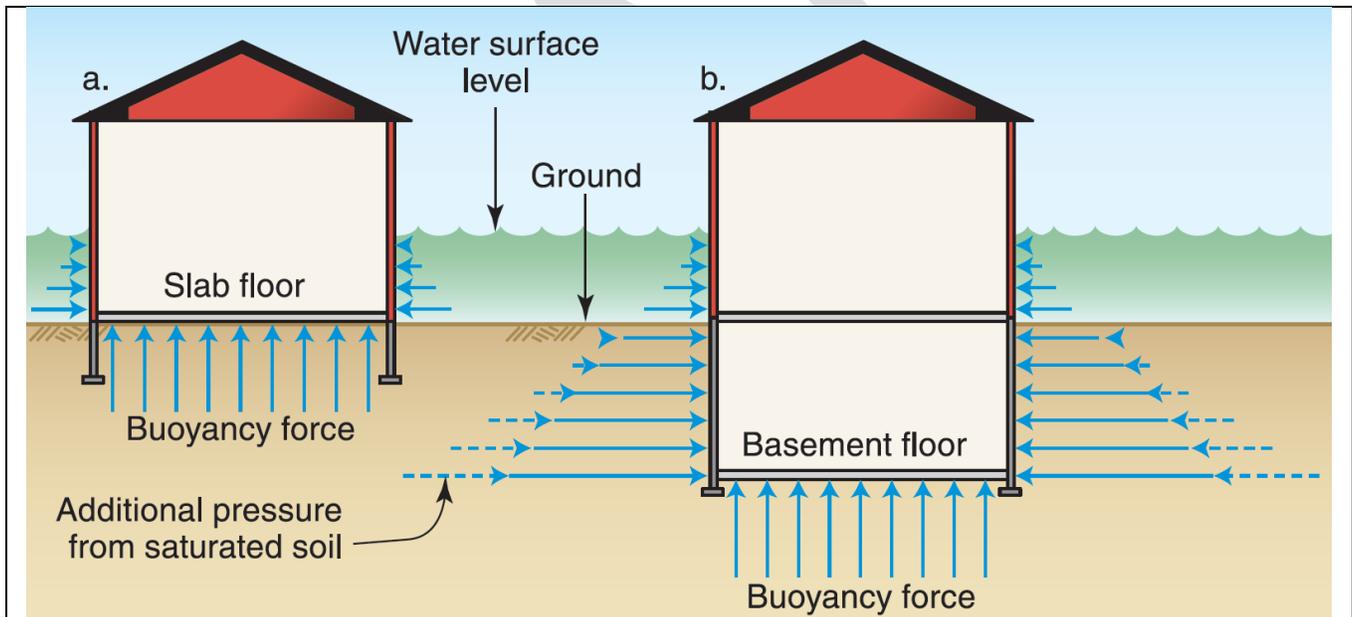
Figure 7-1. Dry Floodproofing Example

Dry floodproofing consists of completely sealing around the exterior of the building so that water cannot enter the building (see Figure 7-1). Dry floodproofing is not a good option for areas where floodwater is deep or flows quickly. The hydrostatic pressure and/or hydrodynamic force can structurally damage the building by causing the walls to collapse or causing the entire structure to float. However, in areas that have minimal velocity and low depth, dry floodproofing can be a good option.

Many flood hazards can be mitigated with various forms of dry floodproofing. Properties that do not have adequate protection of their low opening (window or basement door) can effectively raise the low opening height with a window well or a flood gate. The ultimate height of the low opening depends on several factors, such as the level of flood protection desired, appearance, and cost. The flood protection elevation could be set 1 foot higher than the existing low opening elevation, or it could be set to match the elevation of the lowest opening into a home that cannot be raised. This might be the elevation of the threshold of a door, for example.

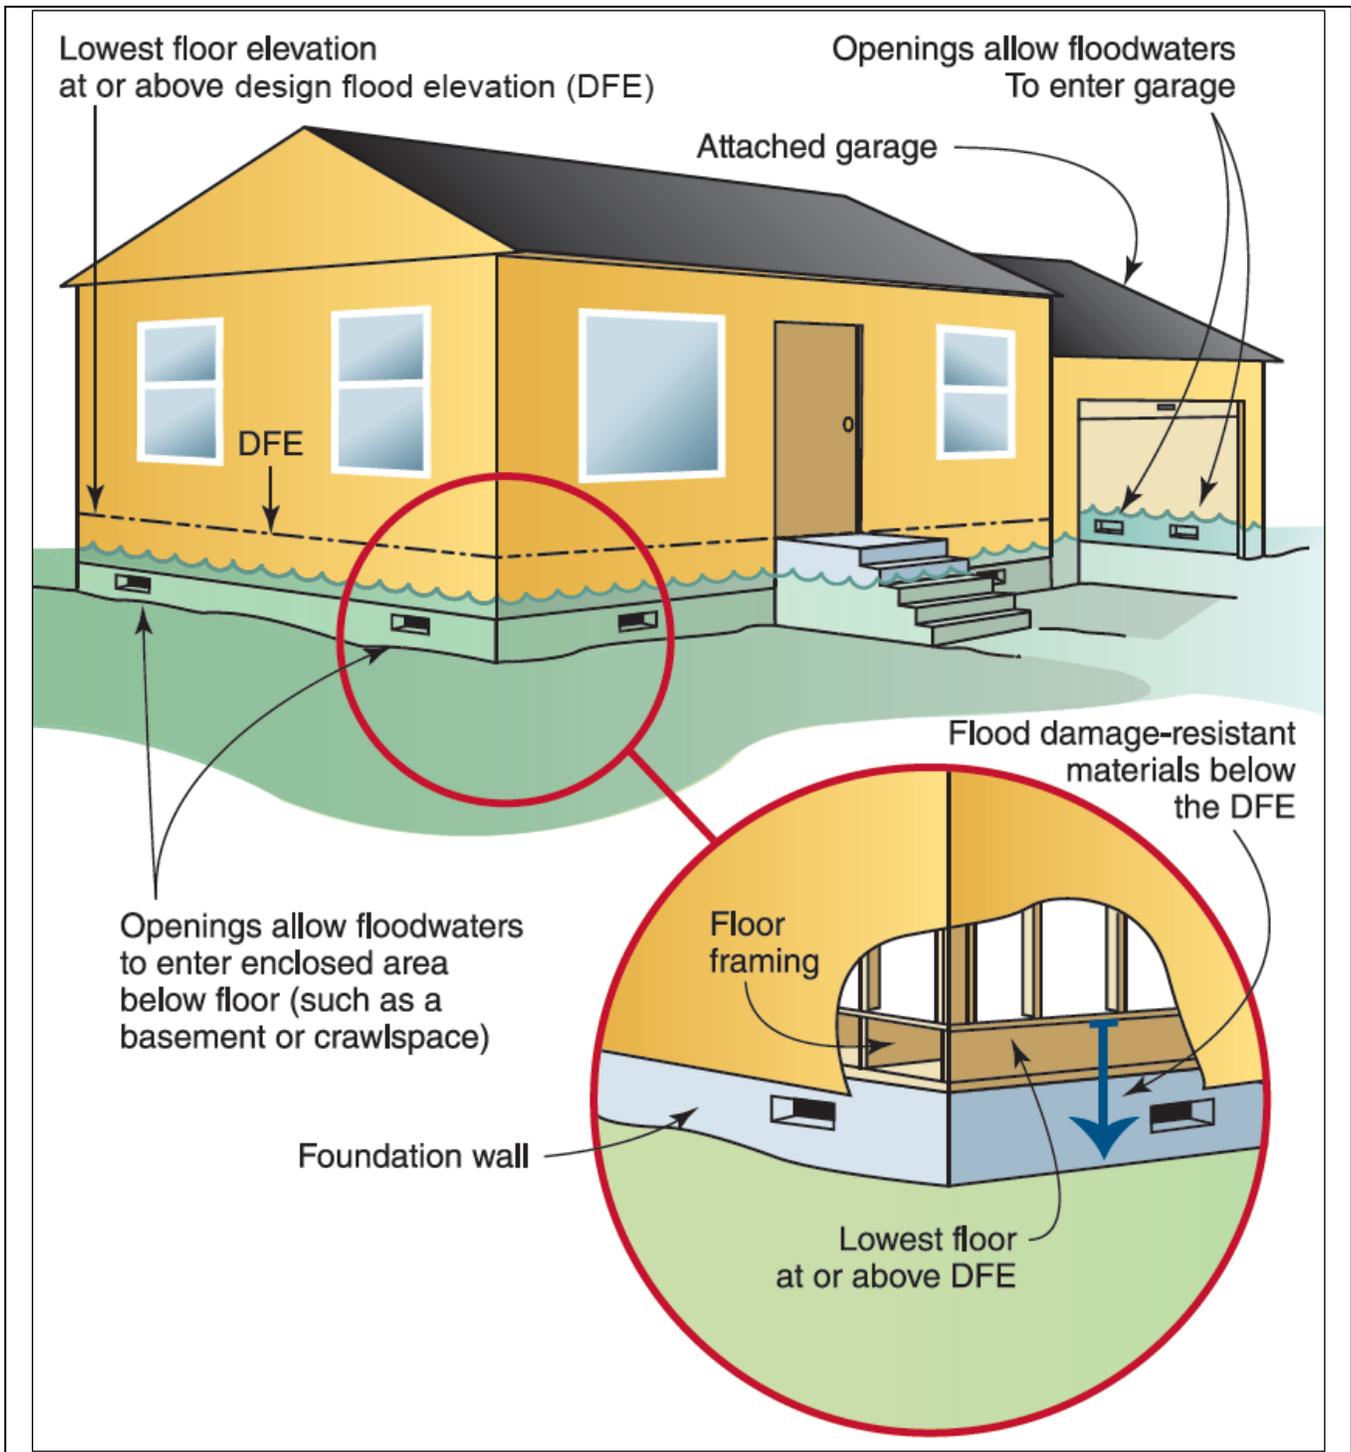
Figure 7-2. Wet Floodproofing Example

Wet floodproofing requires portions of the building to be cleared of valuable items and mechanical utilities. A key component of wet floodproofing is providing openings large enough for the water to flow through the structure, such that the elevation of the water in the structure is equal to the elevation of the water outside of the structure. This equilibrium of floodwater prevents hydrostatic pressure from damaging structural walls.

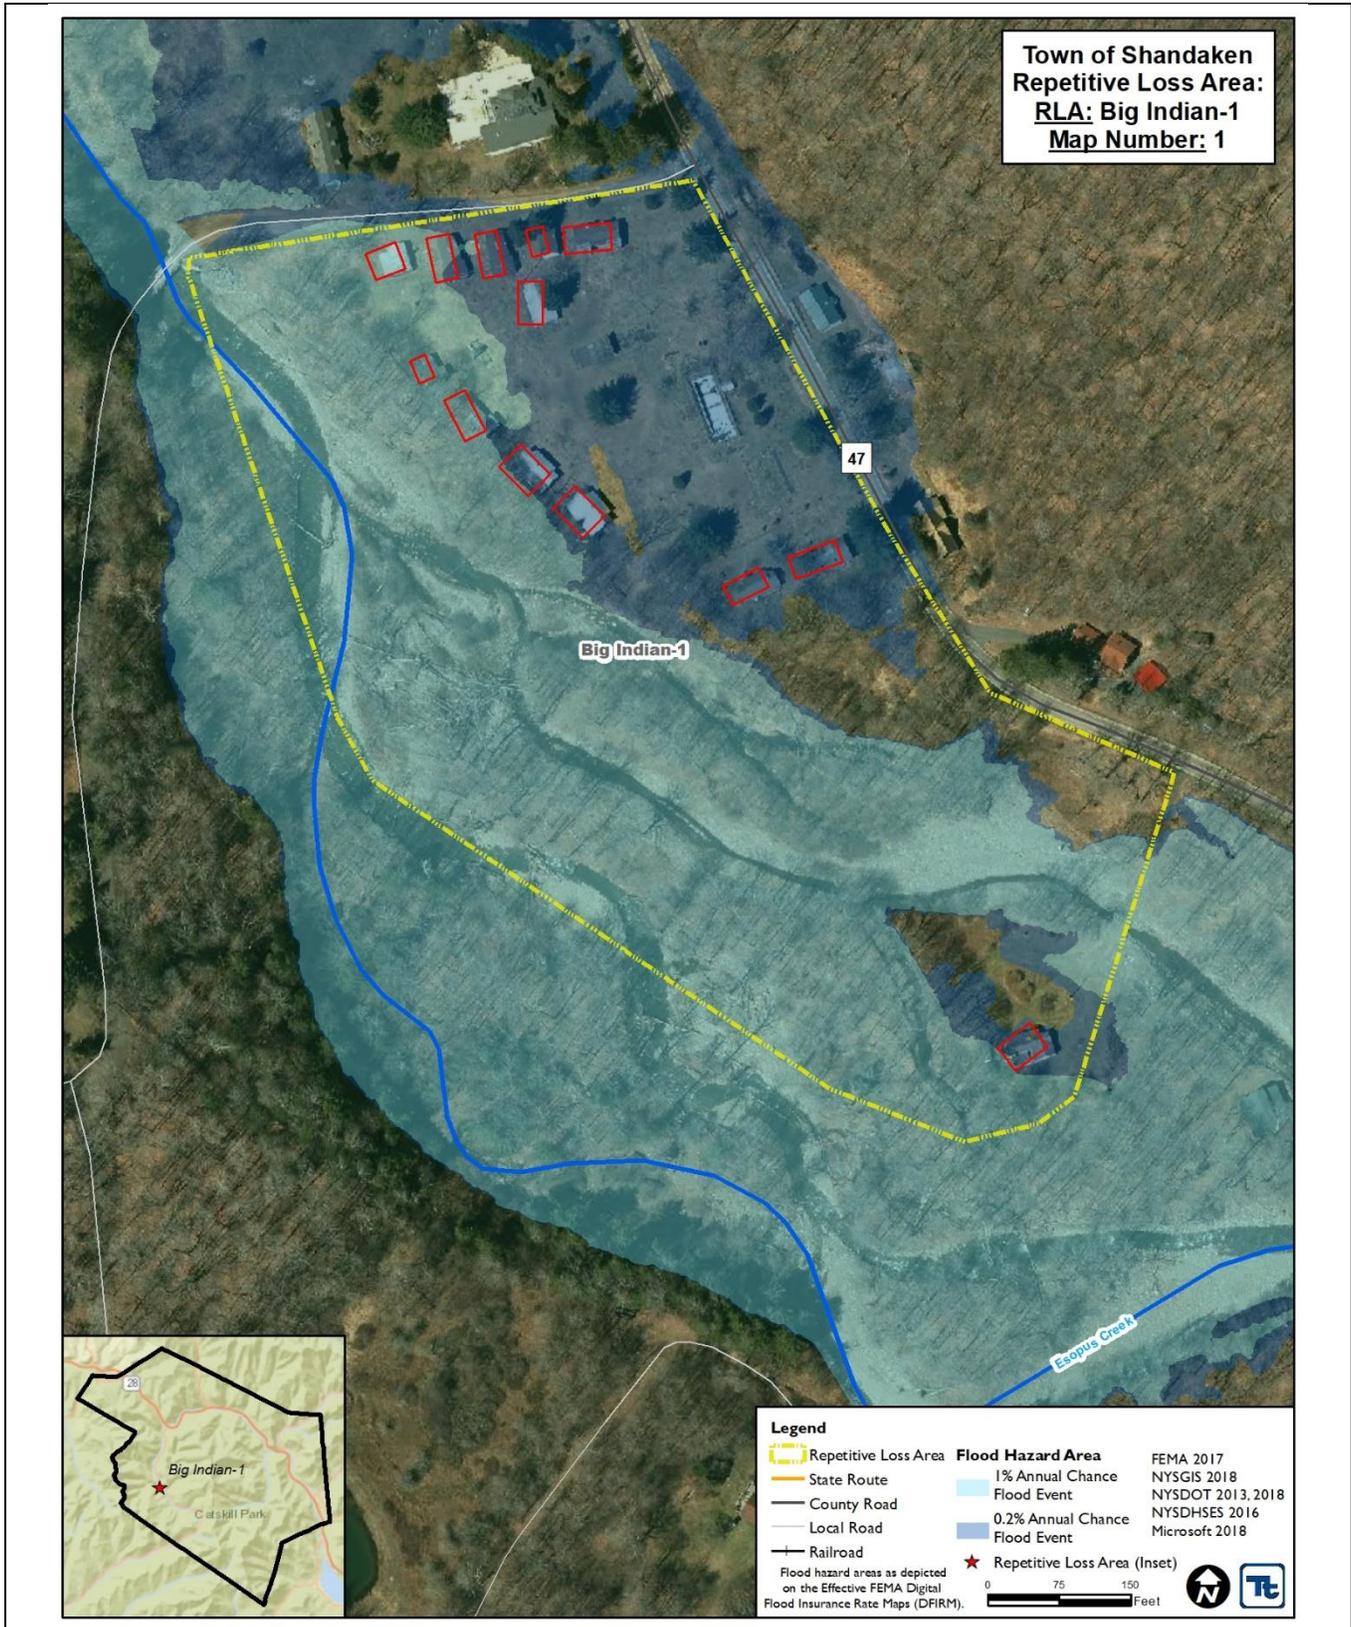
Figure 9-1. Subarea – Big Indian-1 Repetitive Loss Area

Property ID	Number of Insurable Buildings	Building Description		Probable Mitigation Measures
		Foundation	Condition	
BI-8	1	Slab	Normal	Drainage System Maintenance or Enhancements Acquisition Structural Elevation Elevate Utilities Public education
BI-9	1	Slab	Normal	Drainage System Maintenance or Enhancements Acquisition Structural Elevation Elevate Utilities Public education
BI-10	1	Slab	Normal	Drainage System Maintenance or Enhancements Acquisition Structural Elevation Elevate Utilities Public education
BI-11	1	Slab	Normal	Drainage System Maintenance or Enhancements Acquisition Structural Elevation Elevate Utilities Public education
BI-12	1	Slab	Normal	Drainage System Maintenance or Enhancements Acquisition Structural Elevation Elevate Utilities Public education
BI-13	1	Slab	Normal	Drainage System Maintenance or Enhancements Acquisition Structural Elevation Elevate Utilities Public education
<b>Total</b>	<b>13</b>

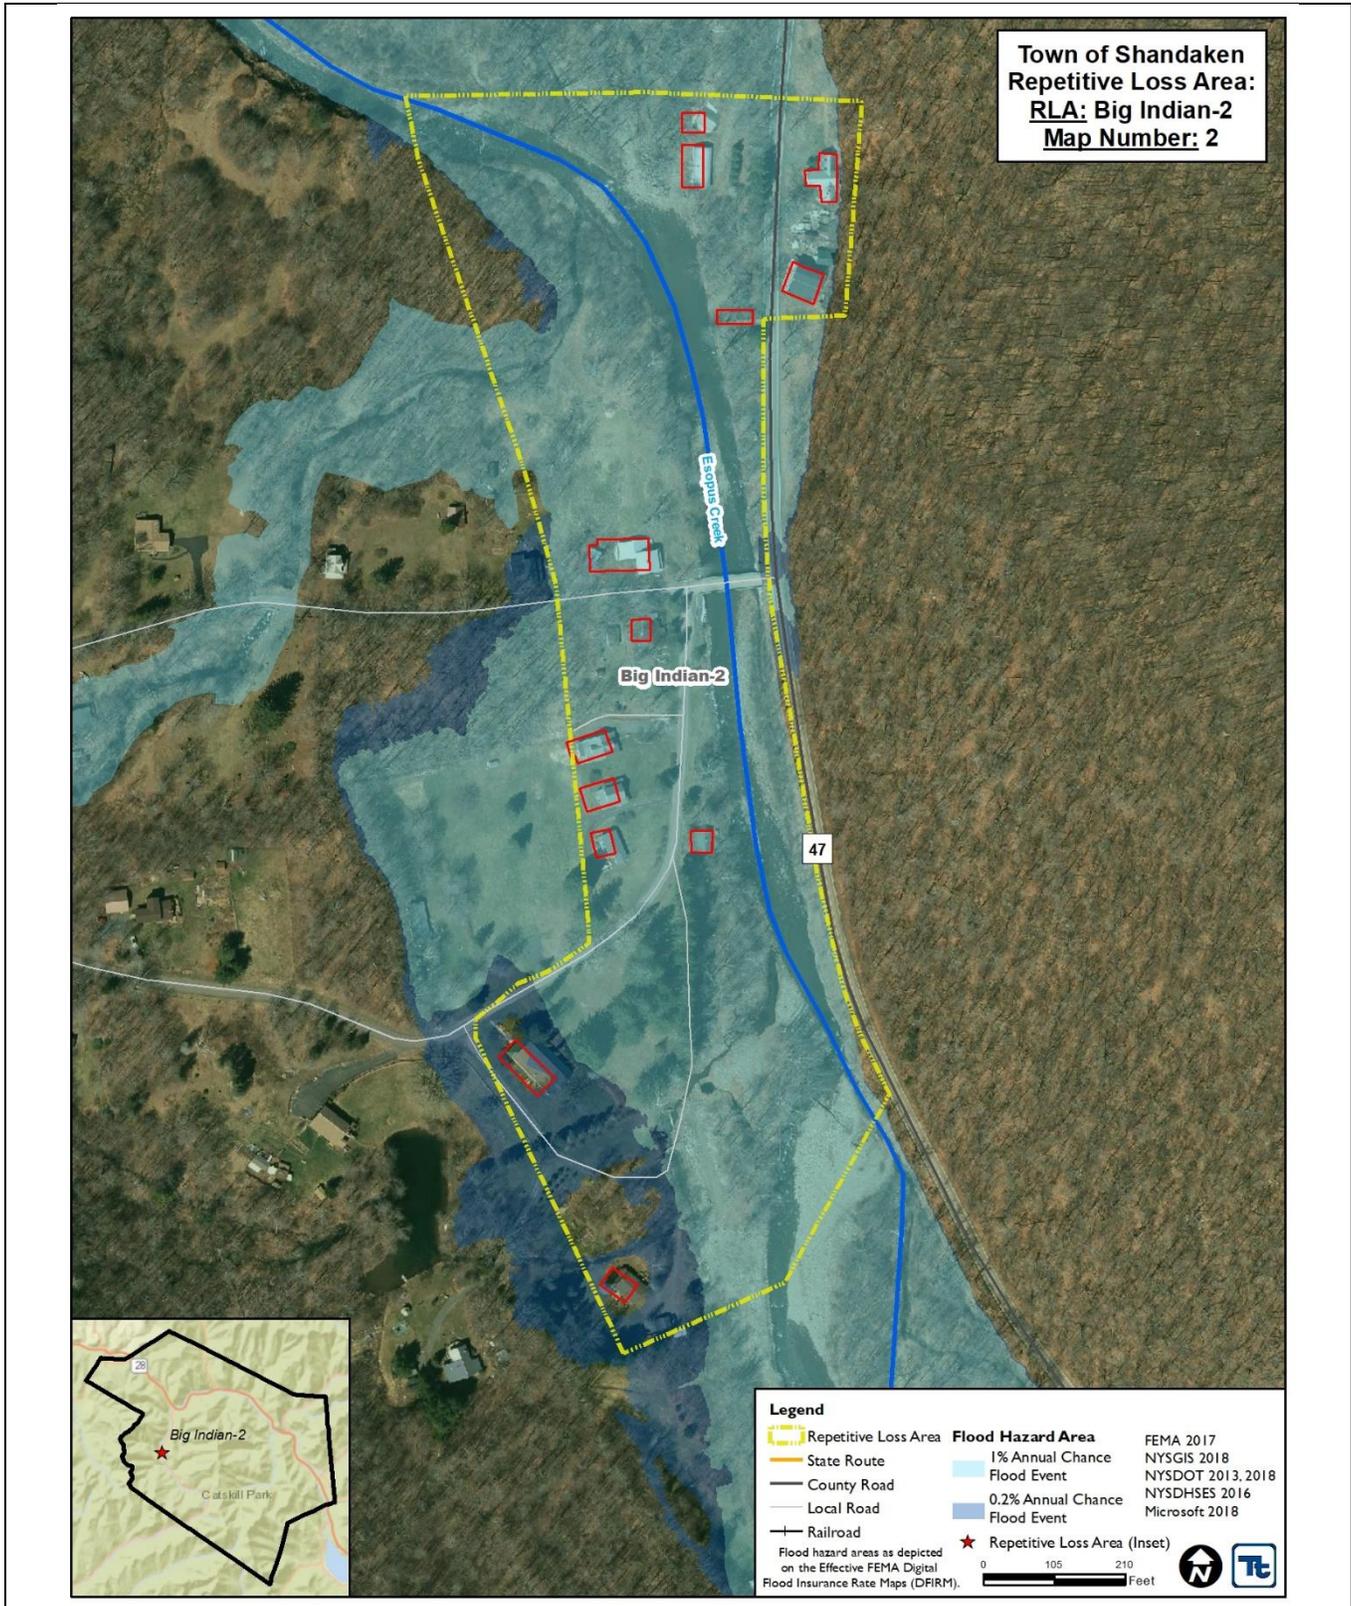
Figure 10-1. Subarea – Big Indian-2 Repetitive Loss Area

BI-21	1	Crawlspace	Normal	Drainage System Maintenance or Enhancements Acquisition Structural Elevation Elevate Utilities Public education
<b>Total</b>	<b>8</b>

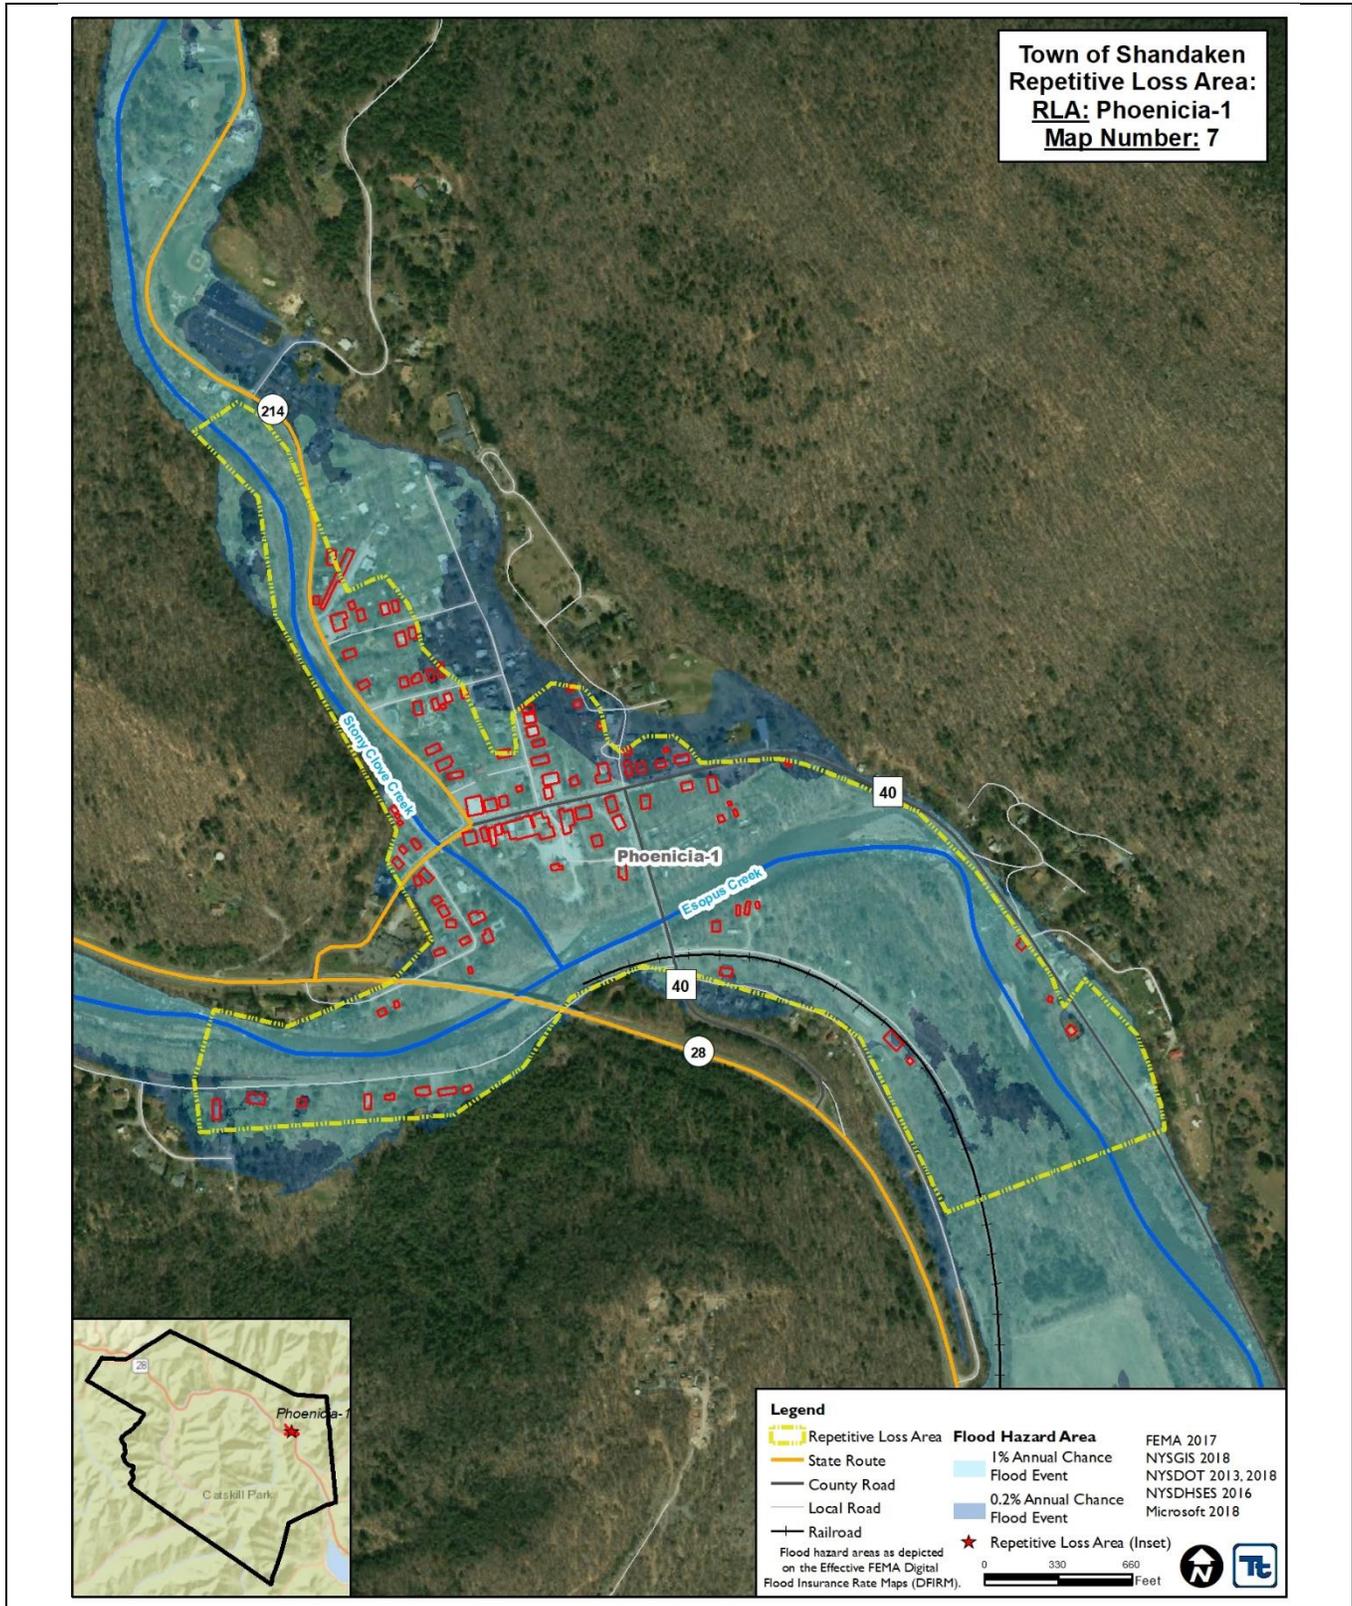
Figure 14-1. Subarea – Phoenicia-1 Repetitive Loss Area

P-108	1	Slab	Normal	Drainage System Maintenance or Enhancements Acquisition Structural Elevation Elevate Utilities Public education
P-109	1	Slab	Normal	Drainage System Maintenance or Enhancements Acquisition Structural Elevation Elevate Utilities Public education
P-110	1	Slab	Normal	Drainage System Maintenance or Enhancements Acquisition Structural Elevation Elevate Utilities Public education
<b>Total</b>	<b>110</b>

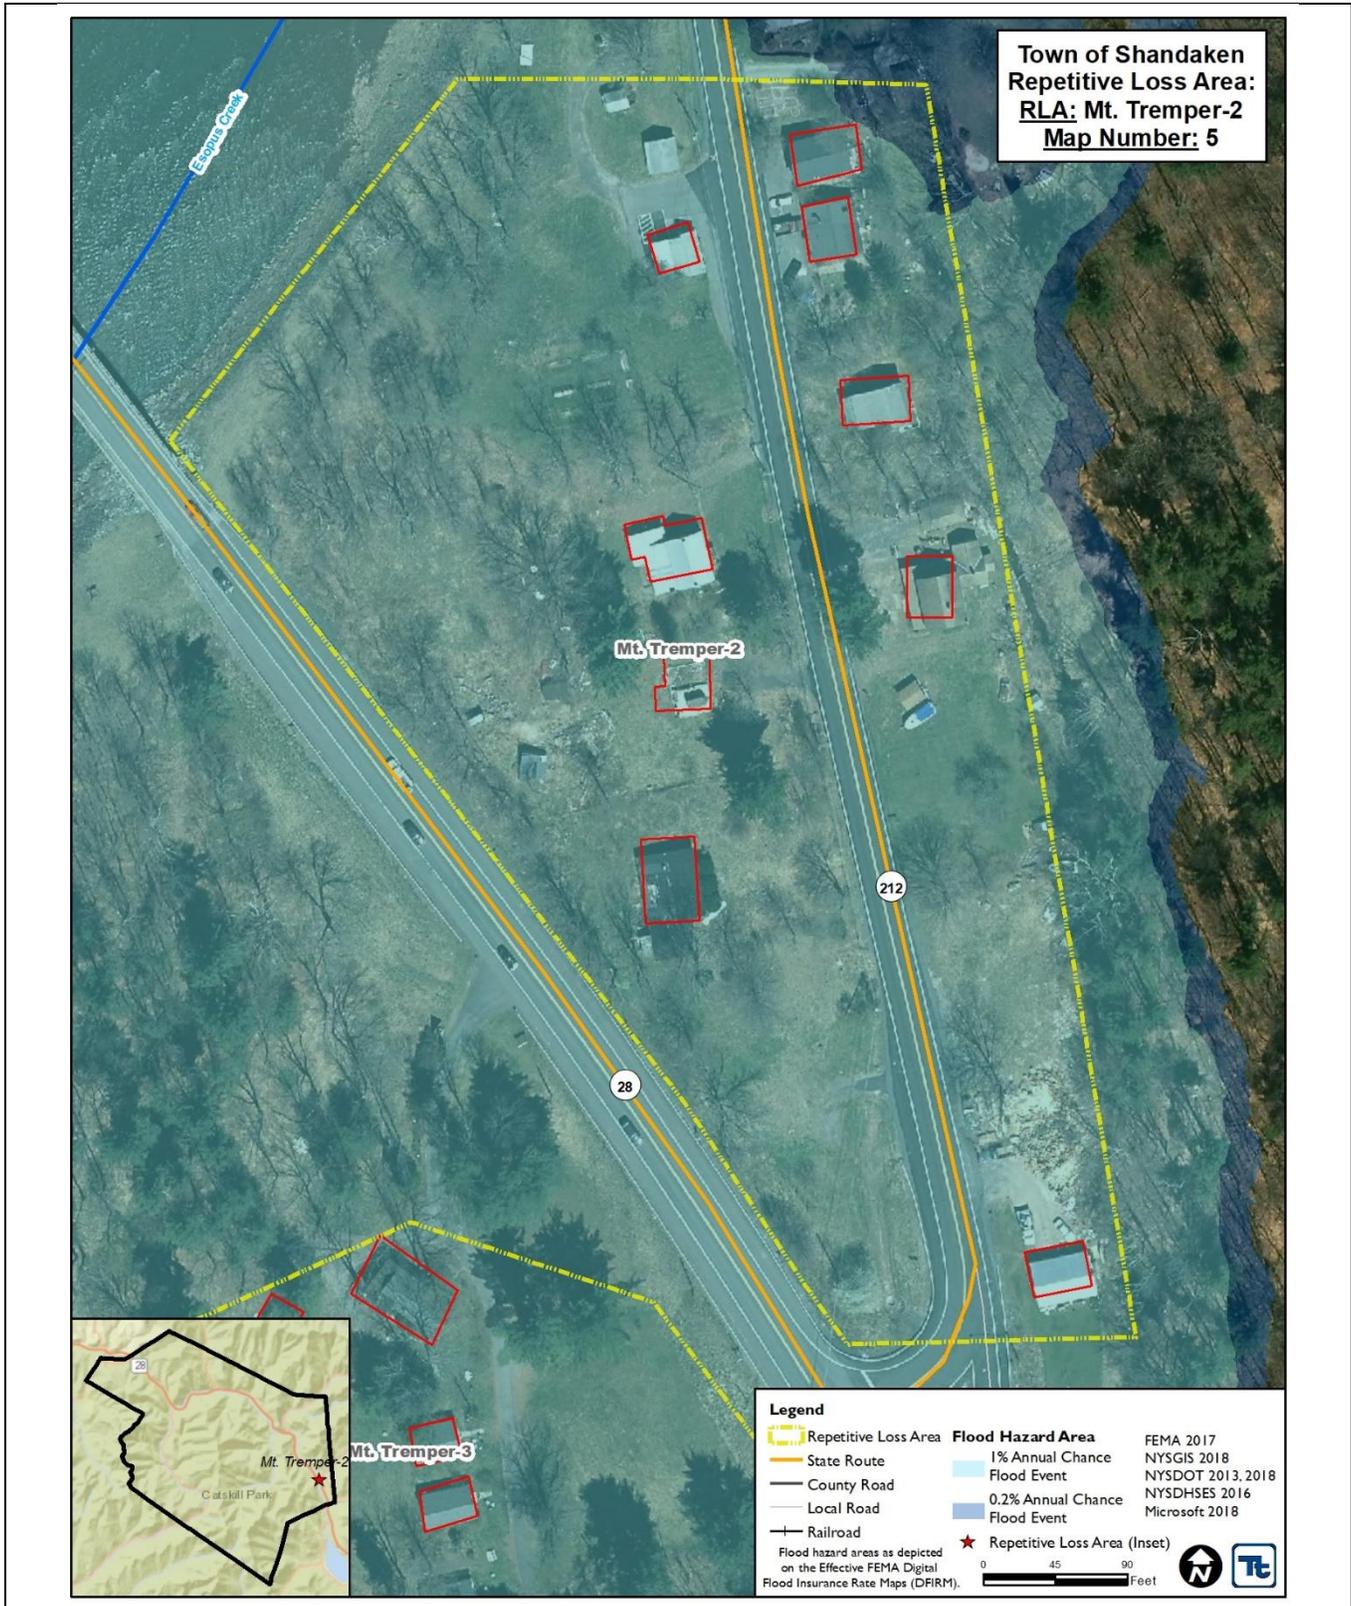
Figure 18-1. Subarea – Mt. Tremper-2 Repetitive Loss Area

MT-12	1	Slab	Normal	Structure demolished; new construction will be built to code
<b>Total</b>	<b>11</b>
