Town of Shandaken, New York

Repetitive Loss Area Analysis

5-Year Update

October 2025

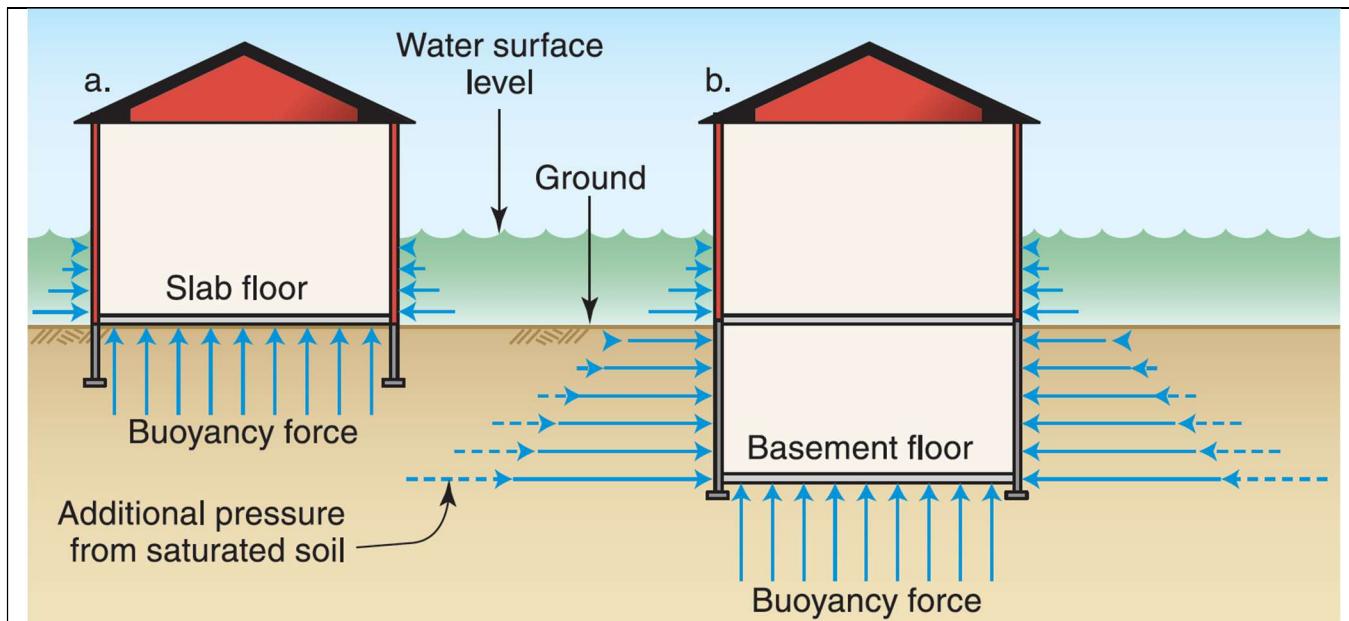
Figure 7-1. Dry Floodproofing Example

Dry floodproofing consists of completely sealing around the exterior of the building so that water cannot enter the building (see Figure 7-1). Dry floodproofing is not a good option for areas where floodwater is deep or in areas of high velocity flows. The hydrostatic pressure and/or hydrodynamic force can structurally damage the building by causing the walls to collapse or causing the entire structure to float. However, in areas that have minimal velocity and low depth, dry floodproofing can be a good option.

Many flood hazards can be mitigated with various forms of dry floodproofing. Properties that do not have adequate protection of their low opening (window or basement door) can effectively raise the low opening height with a window well or a flood gate. The ultimate height of the low opening depends on several factors, such as the

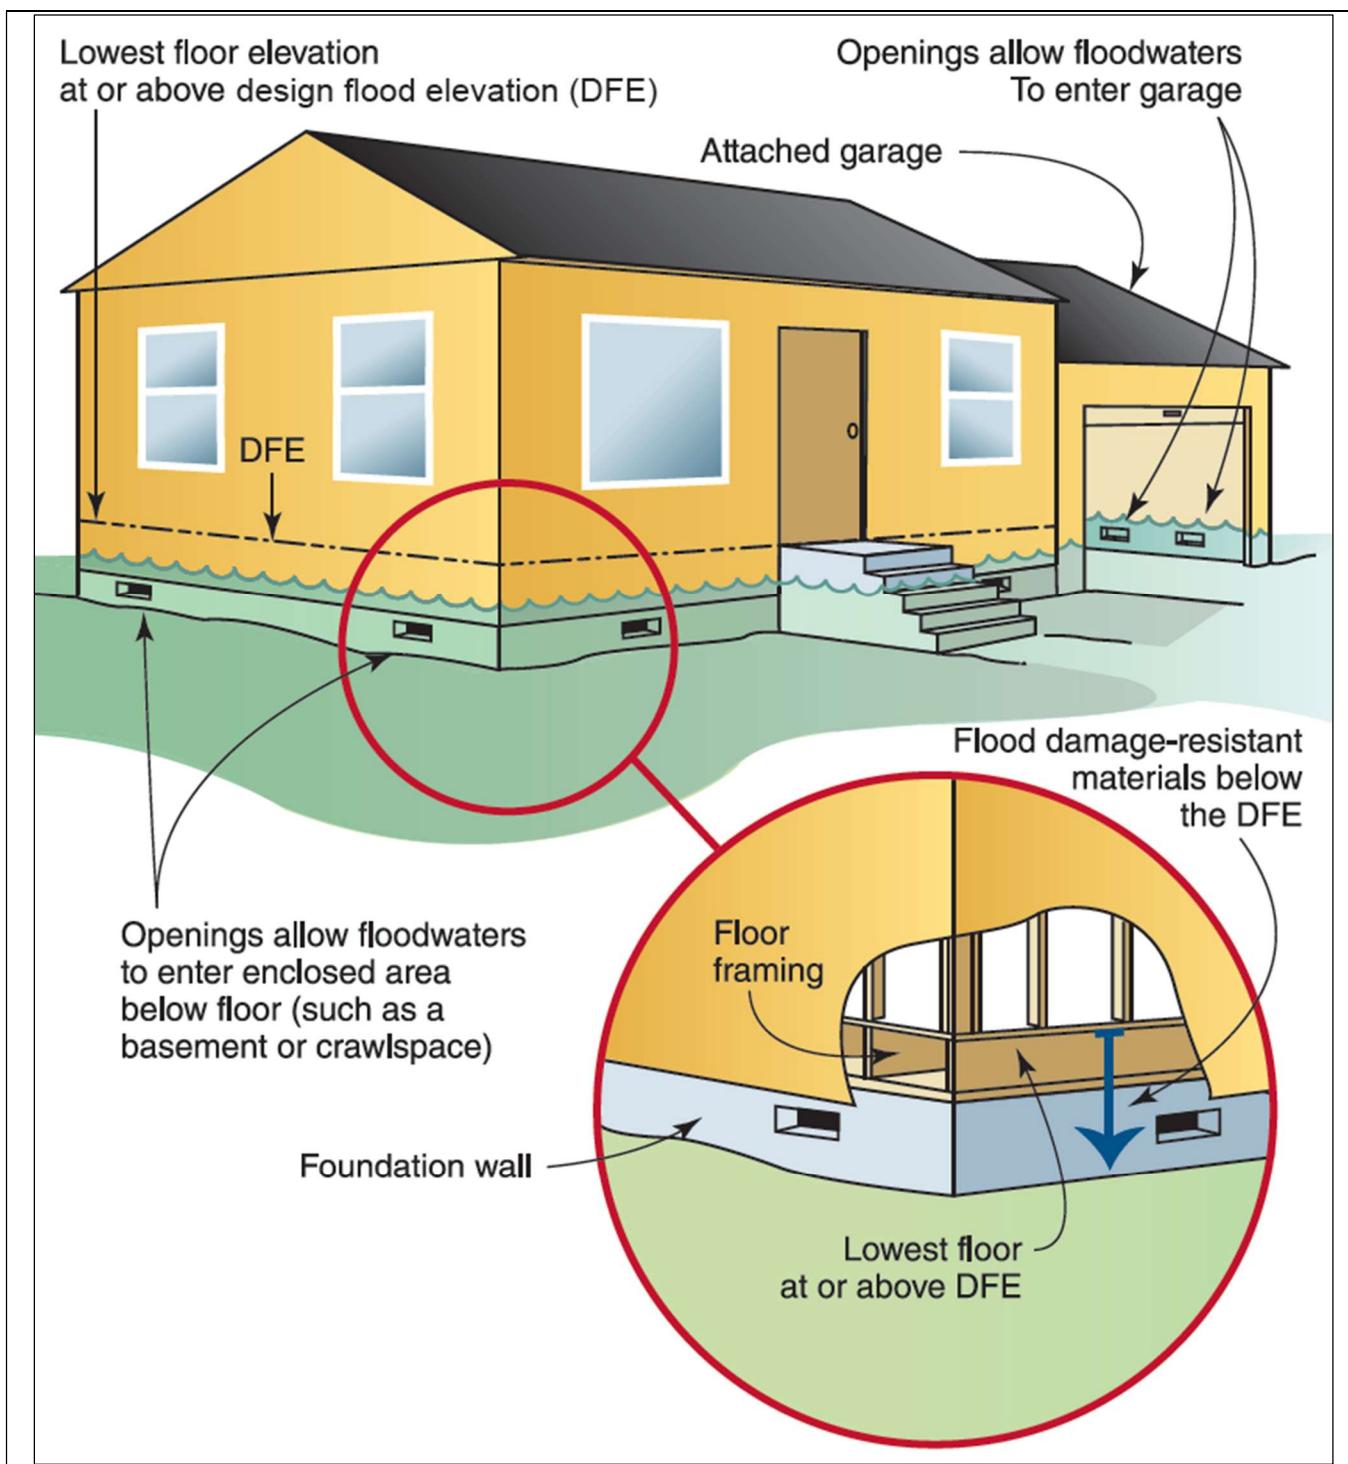
Figure 7-2. Wet Floodproofing Example

Wet floodproofing consists of modifying uninhabited portions of a home, such as a crawlspace, garage, or unfinished basement, with flood damage-resistant materials to allow floodwaters to enter the structure without causing damage (see Figure 7-2).

Wet floodproofing requires portions of the building to be cleared of valuable items and mechanical utilities. A key component of wet floodproofing is providing openings large enough for the water to flow through the structure, such that the elevation of the water in the structure is equal to the elevation of the water outside of the structure. This equilibrium of floodwater prevents hydrostatic pressure from damaging structural walls.

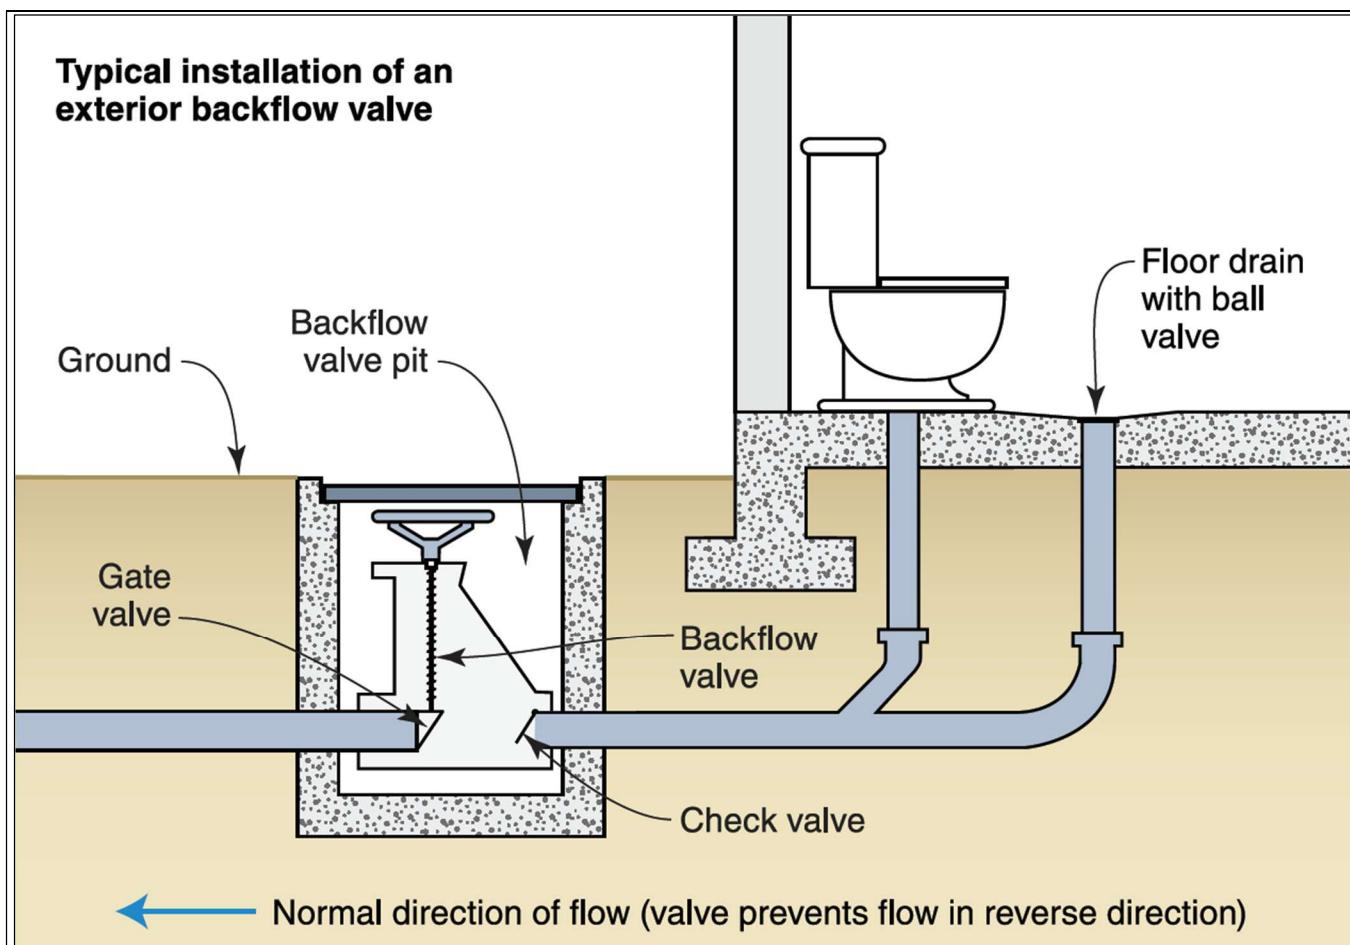
Figure 7-3. Sewer Backflow Valve Installation Example

Heavy rains can saturate the soil and infiltrate the sanitary sewer system through leaky joints or cracks in the pipes. The inflow of stormwater floods the sanitary sewer system, causing water to back up into the home through lower-level plumbing fixtures. This occurrence can be prevented by installing a sewer backflow preventer (see Figure 7-3). A backflow preventer will allow the sanitary sewer water to flow freely from the home to the sewer but restrict the reverse flow. Backflow preventers do require maintenance and can fail if debris in the sewer prevents the valve from sealing properly. An overhead sewer system pumps wastewater from basement level plumbing fixtures up to an elevation near the ground level, where it can drain by gravity into the sewer service line. This higher sewer makes it unlikely that water will back up into the building.

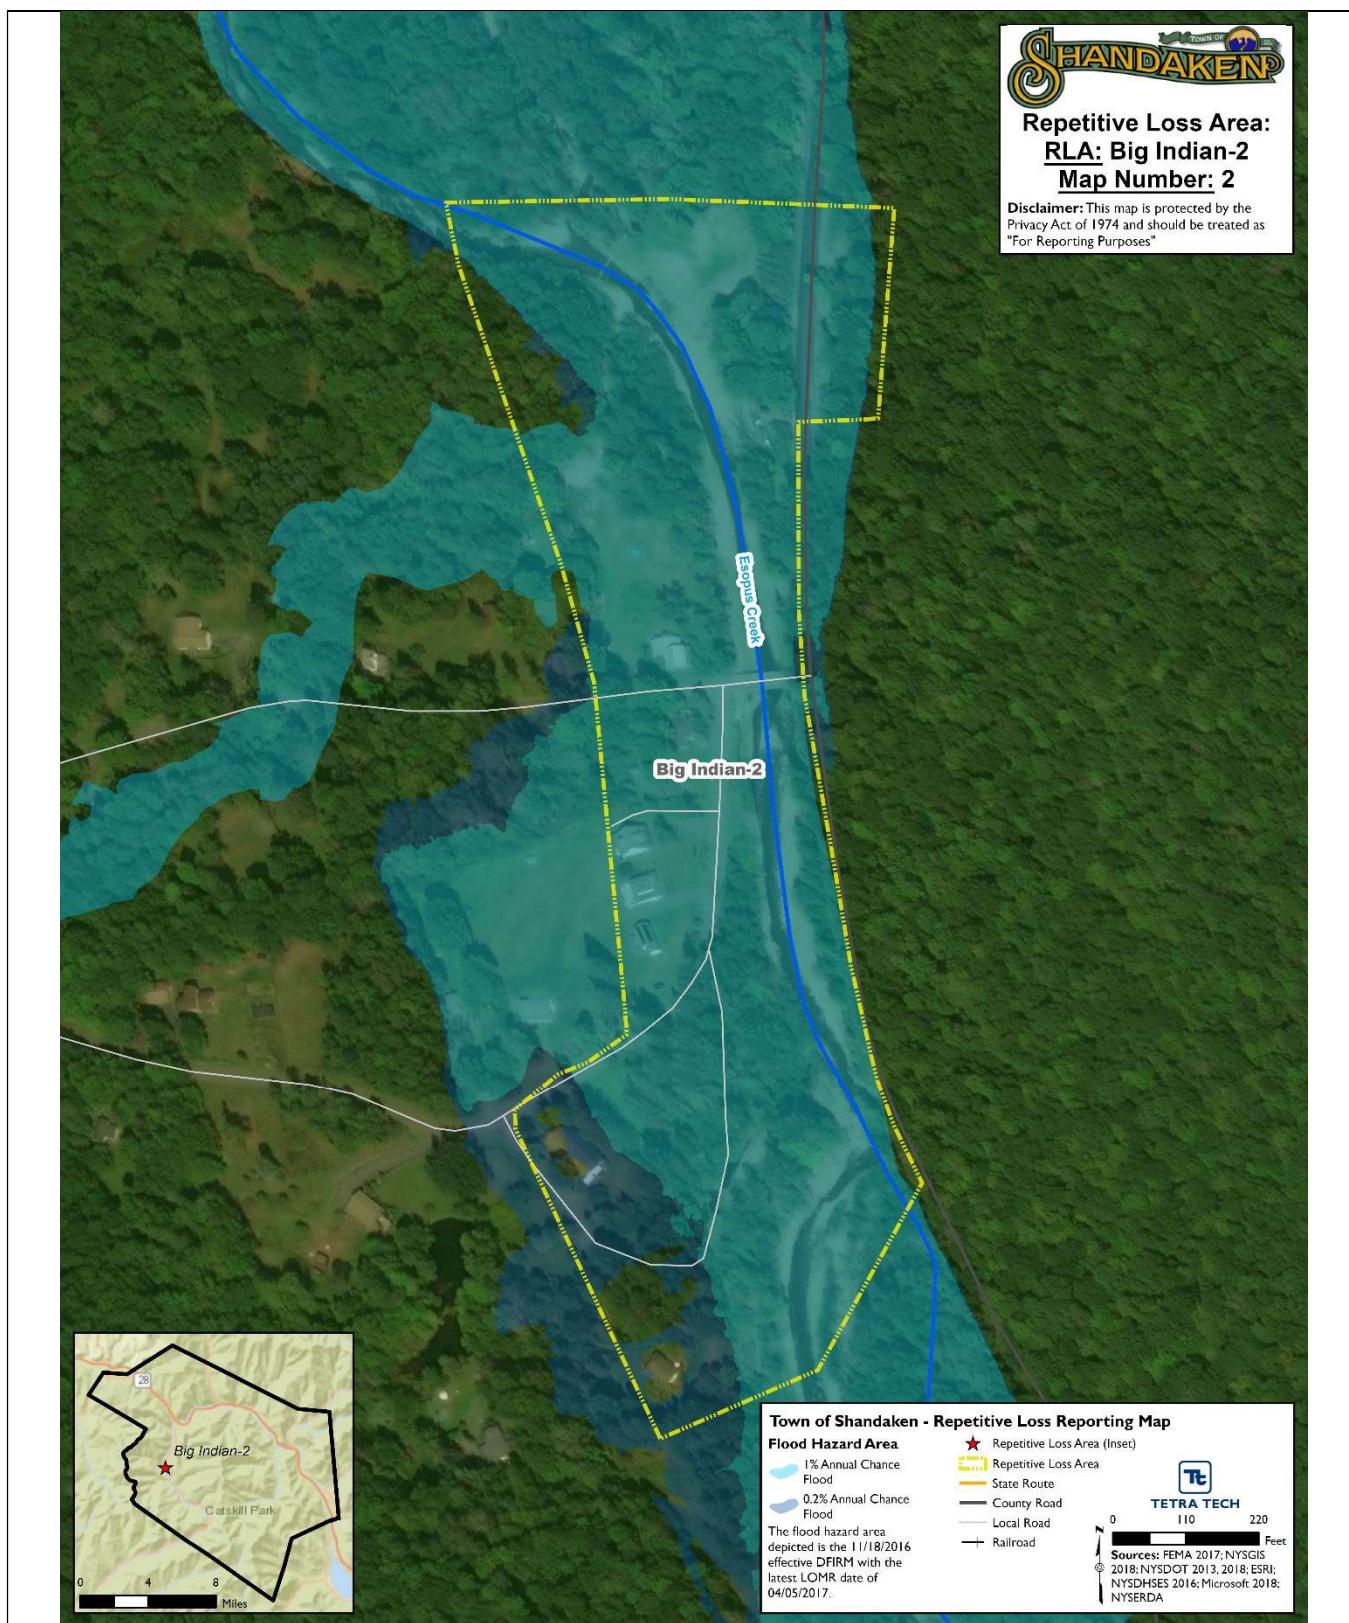
Figure 8-2. Big Indian-2 Repetitive Loss Area 2025

BI-21	1	Crawlspace	Normal	Drainage System Maintenance or Enhancements Acquisition Structural Elevation Elevate Utilities Public education
Total	8

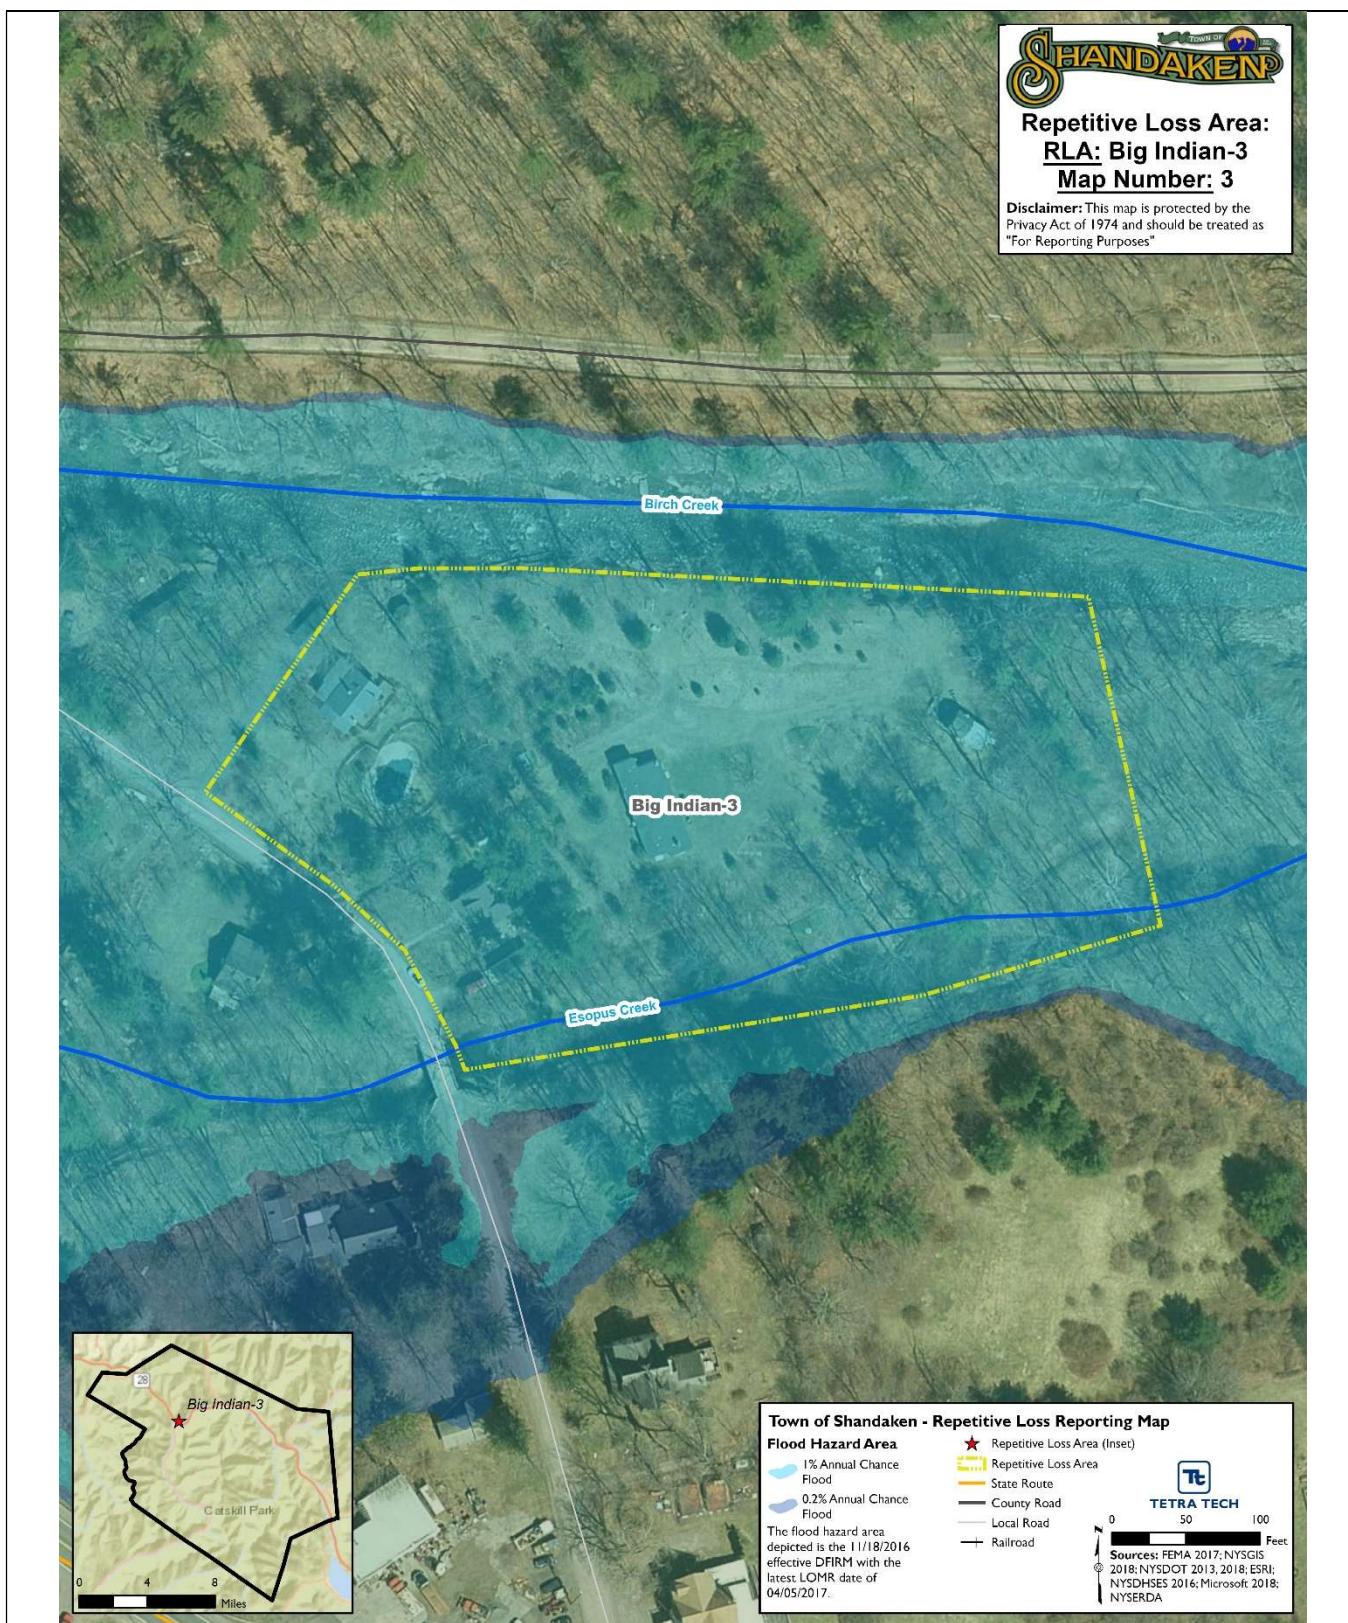
Figure 8-3. Big Indian-3 Repetitive Loss Area 2025

Property ID	Number of Insurable Buildings	Building Description		Probable Mitigation Measures
		Foundation	Condition	
BI-22	1	Crawl space	Excellent	Drainage System Maintenance or Enhancements Acquisition Structural Elevation Elevate Utilities Public education
BI-23	1	Slab	Normal	Drainage System Maintenance or Enhancements Acquisition Structural Elevation Elevate Utilities Public education
BI-24	1	Crawl space	Excellent	Drainage System Maintenance or Enhancements Acquisition Structural Elevation Elevate Utilities Public education
Total	3

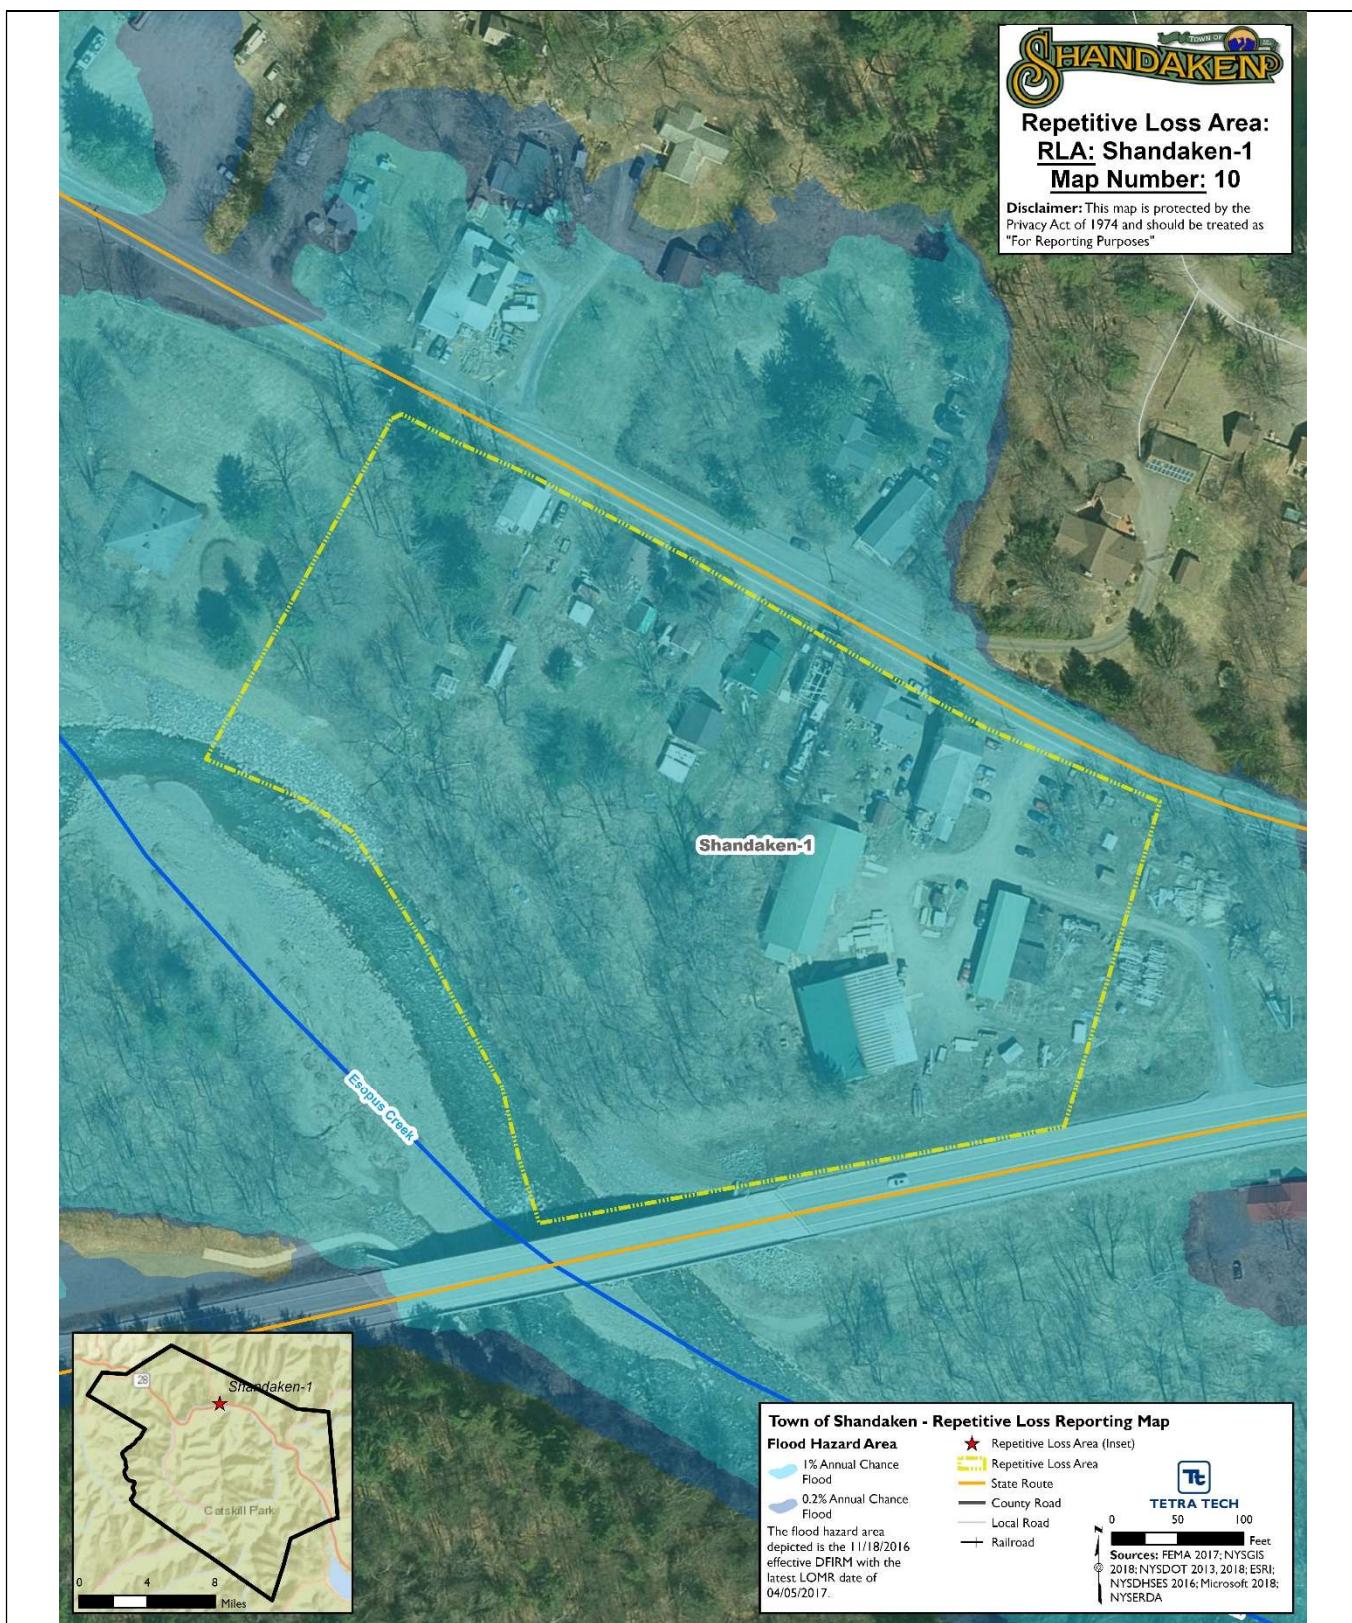
Figure 8-4. Shandaken-1 Repetitive Loss Area 2025

S-7	1	Crawlspace	Normal	Drainage System Maintenance or Enhancements Acquisition Structural Elevation Elevate Utilities Public education
S-8	1	Basement	Normal	Drainage System Maintenance or Enhancements Acquisition Structural Elevation Elevate Utilities Public education
Total	8

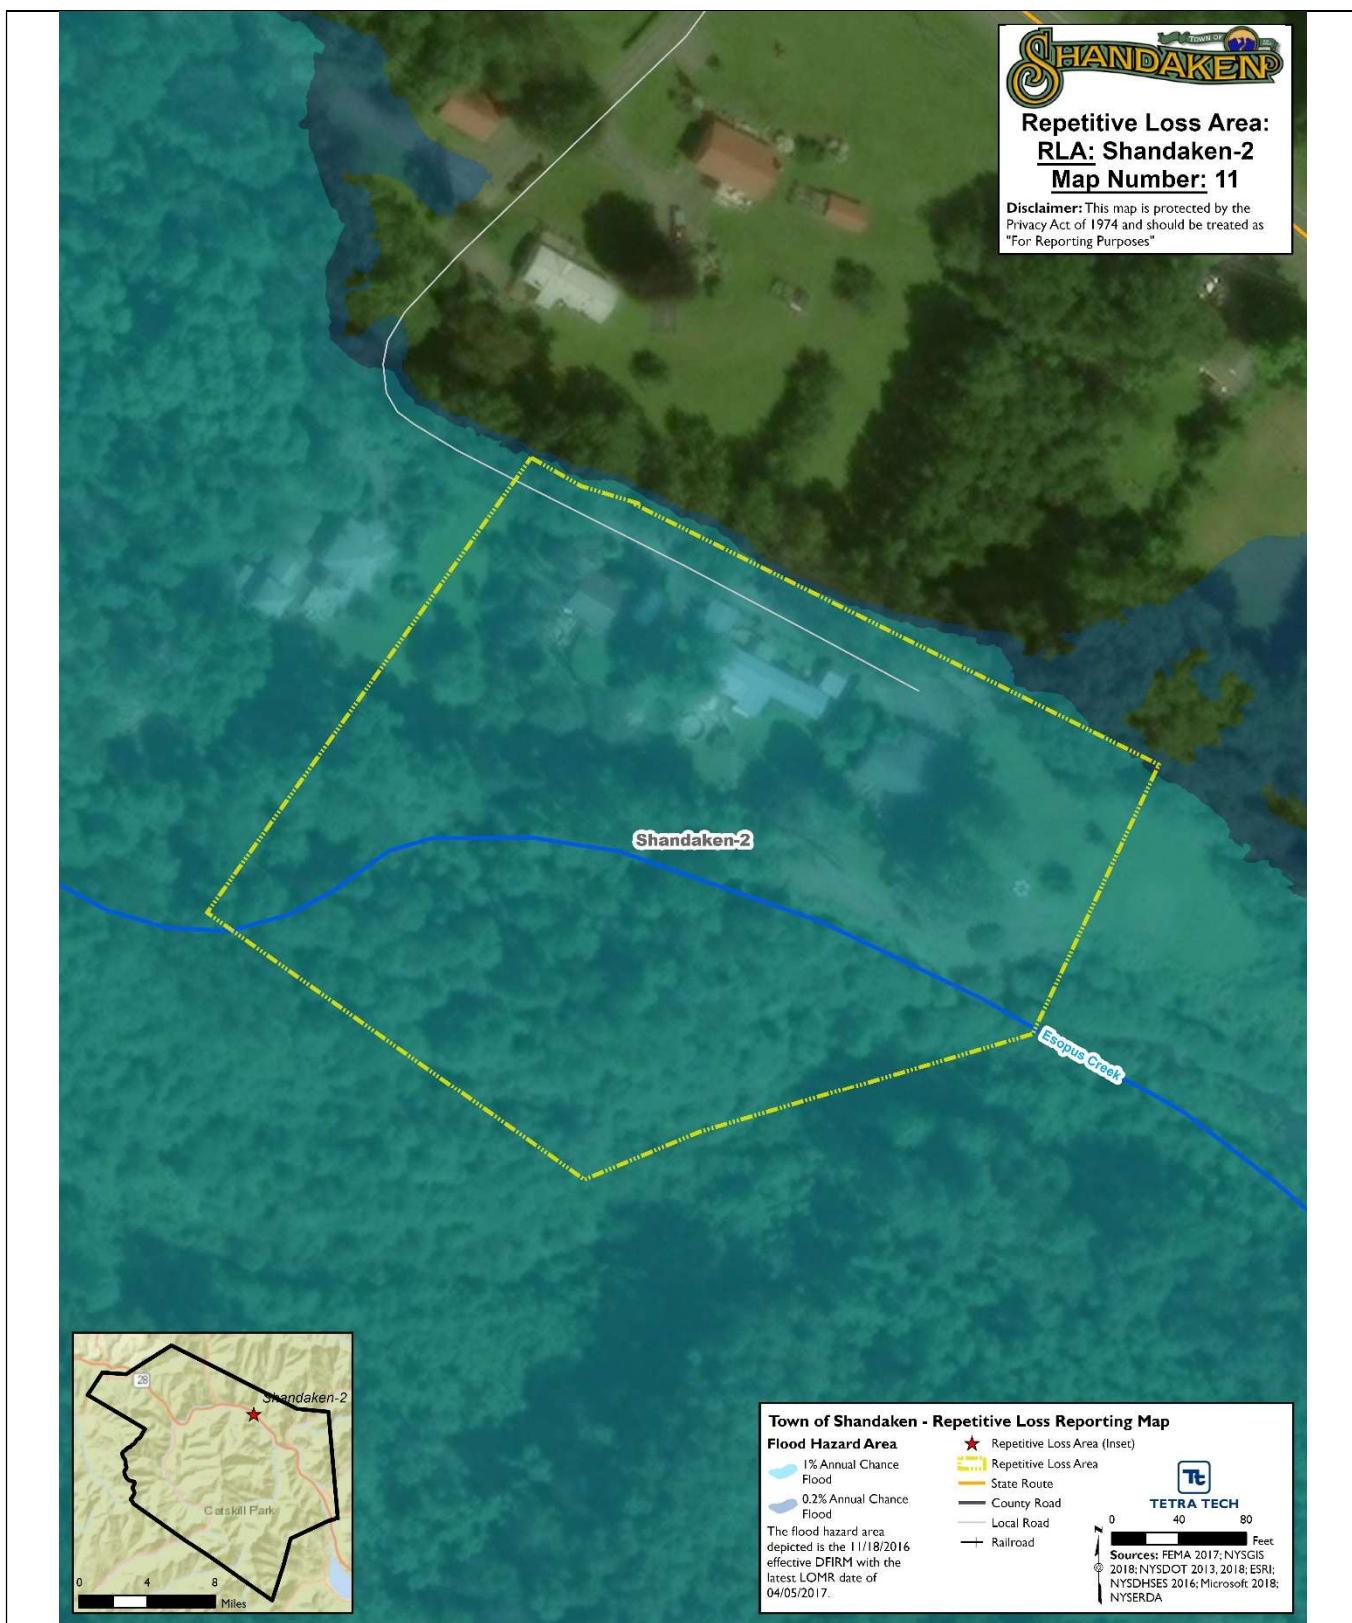
Figure 8-5. Shandaken-2 Repetitive Loss Area 2025

Property ID	Number of Insurable Buildings	Building Description		Probable Mitigation Measures
		Foundation	Condition	
S-9	1	Crawlspace	Fair	Drainage System Maintenance or Enhancements Acquisition Structural Elevation Elevate Utilities Public education
S-10	1	Crawlspace	Good	Drainage System Maintenance or Enhancements Acquisition Structural Elevation Elevate Utilities Public education
S-11	1	Crawlspace	Good	Drainage System Maintenance or Enhancements Acquisition Structural Elevation Elevate Utilities Public education
Total	3

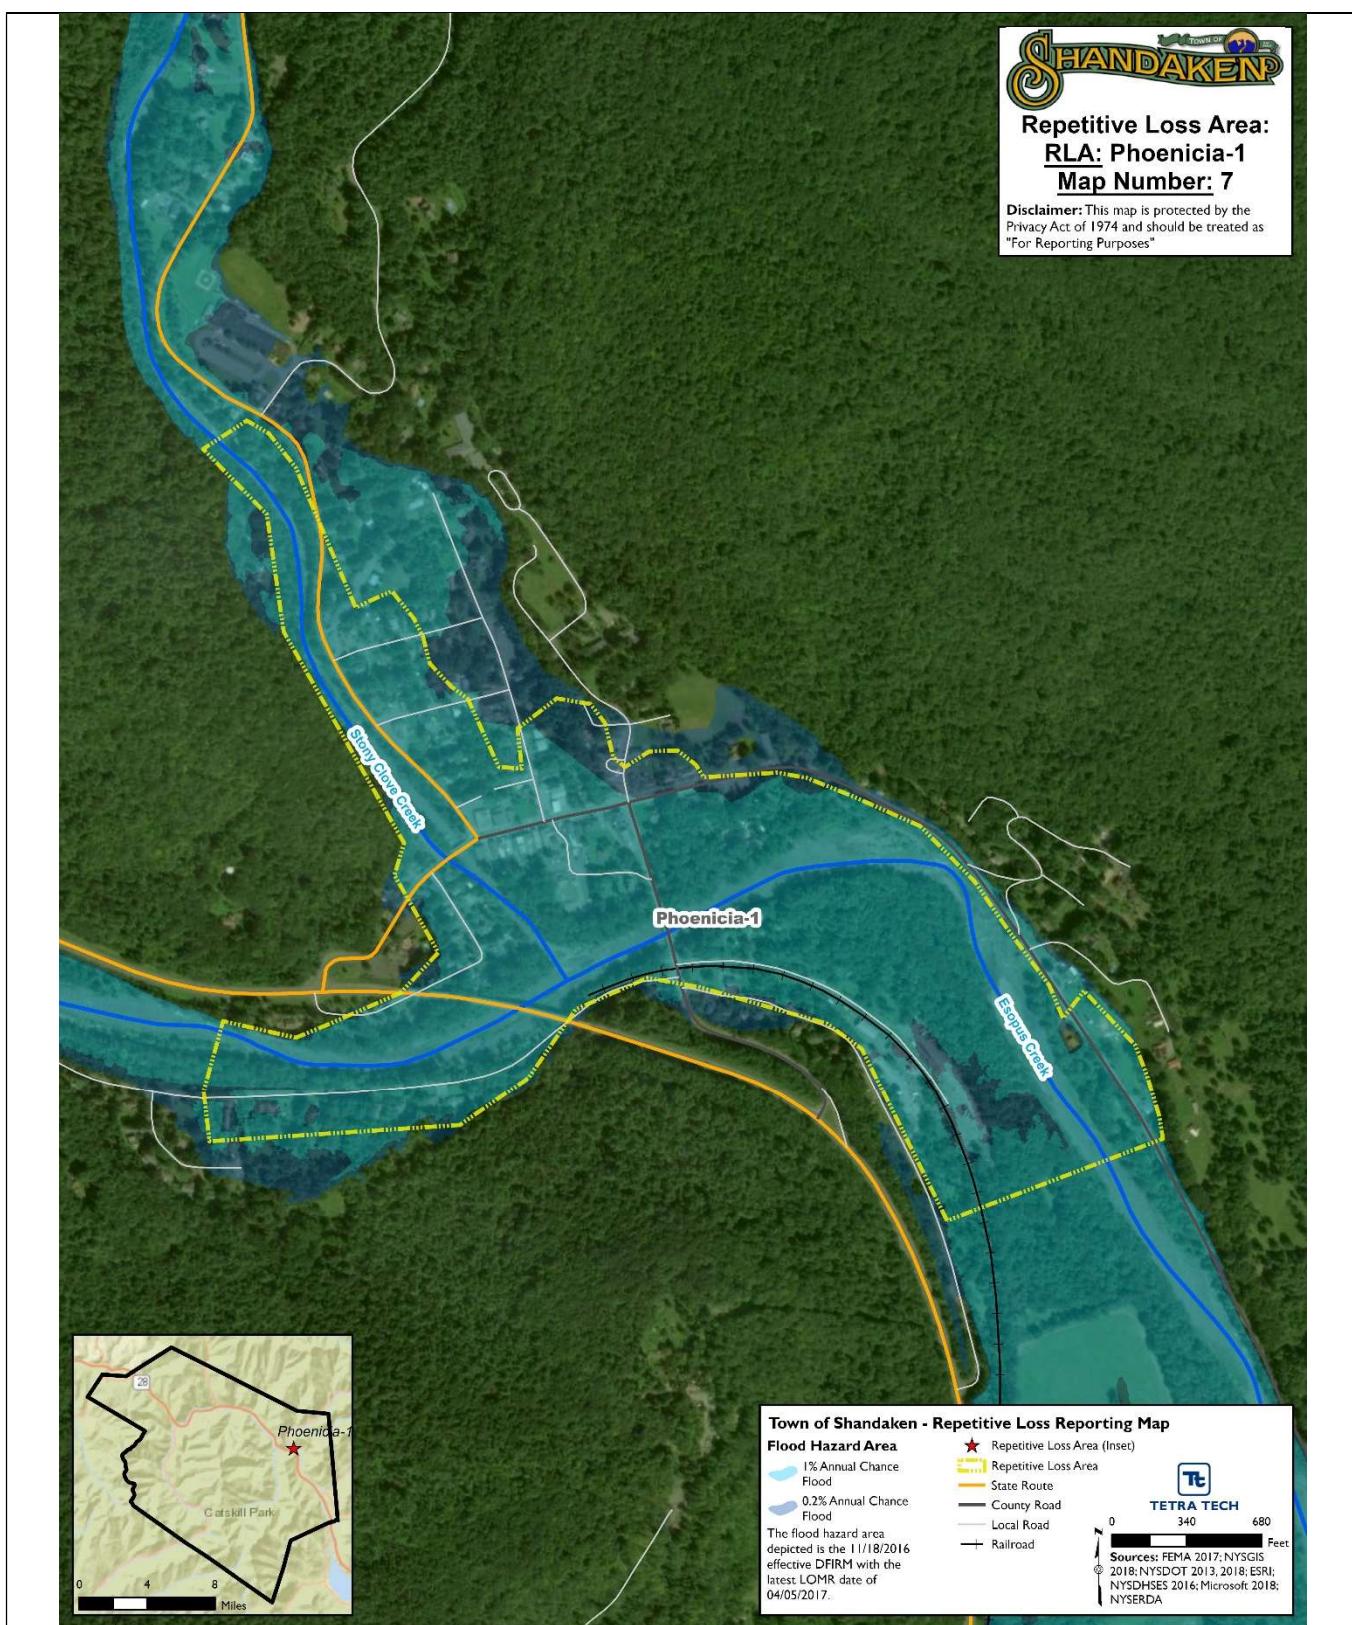
Figure 8-6. Phoenicia-1 Repetitive Loss Area 2025

Property ID	Number of Insurable Buildings	Building Description		Probable Mitigation Measures
		Foundation	Condition	
P-108	1	Slab	Normal	Drainage System Maintenance or Enhancements Acquisition Structural Elevation Elevate Utilities Public education
P-109	1	Slab	Normal	Drainage System Maintenance or Enhancements Acquisition Structural Elevation Elevate Utilities Public education
P-110	1	Slab	Normal	Drainage System Maintenance or Enhancements Acquisition Structural Elevation Elevate Utilities Public education
Total	110

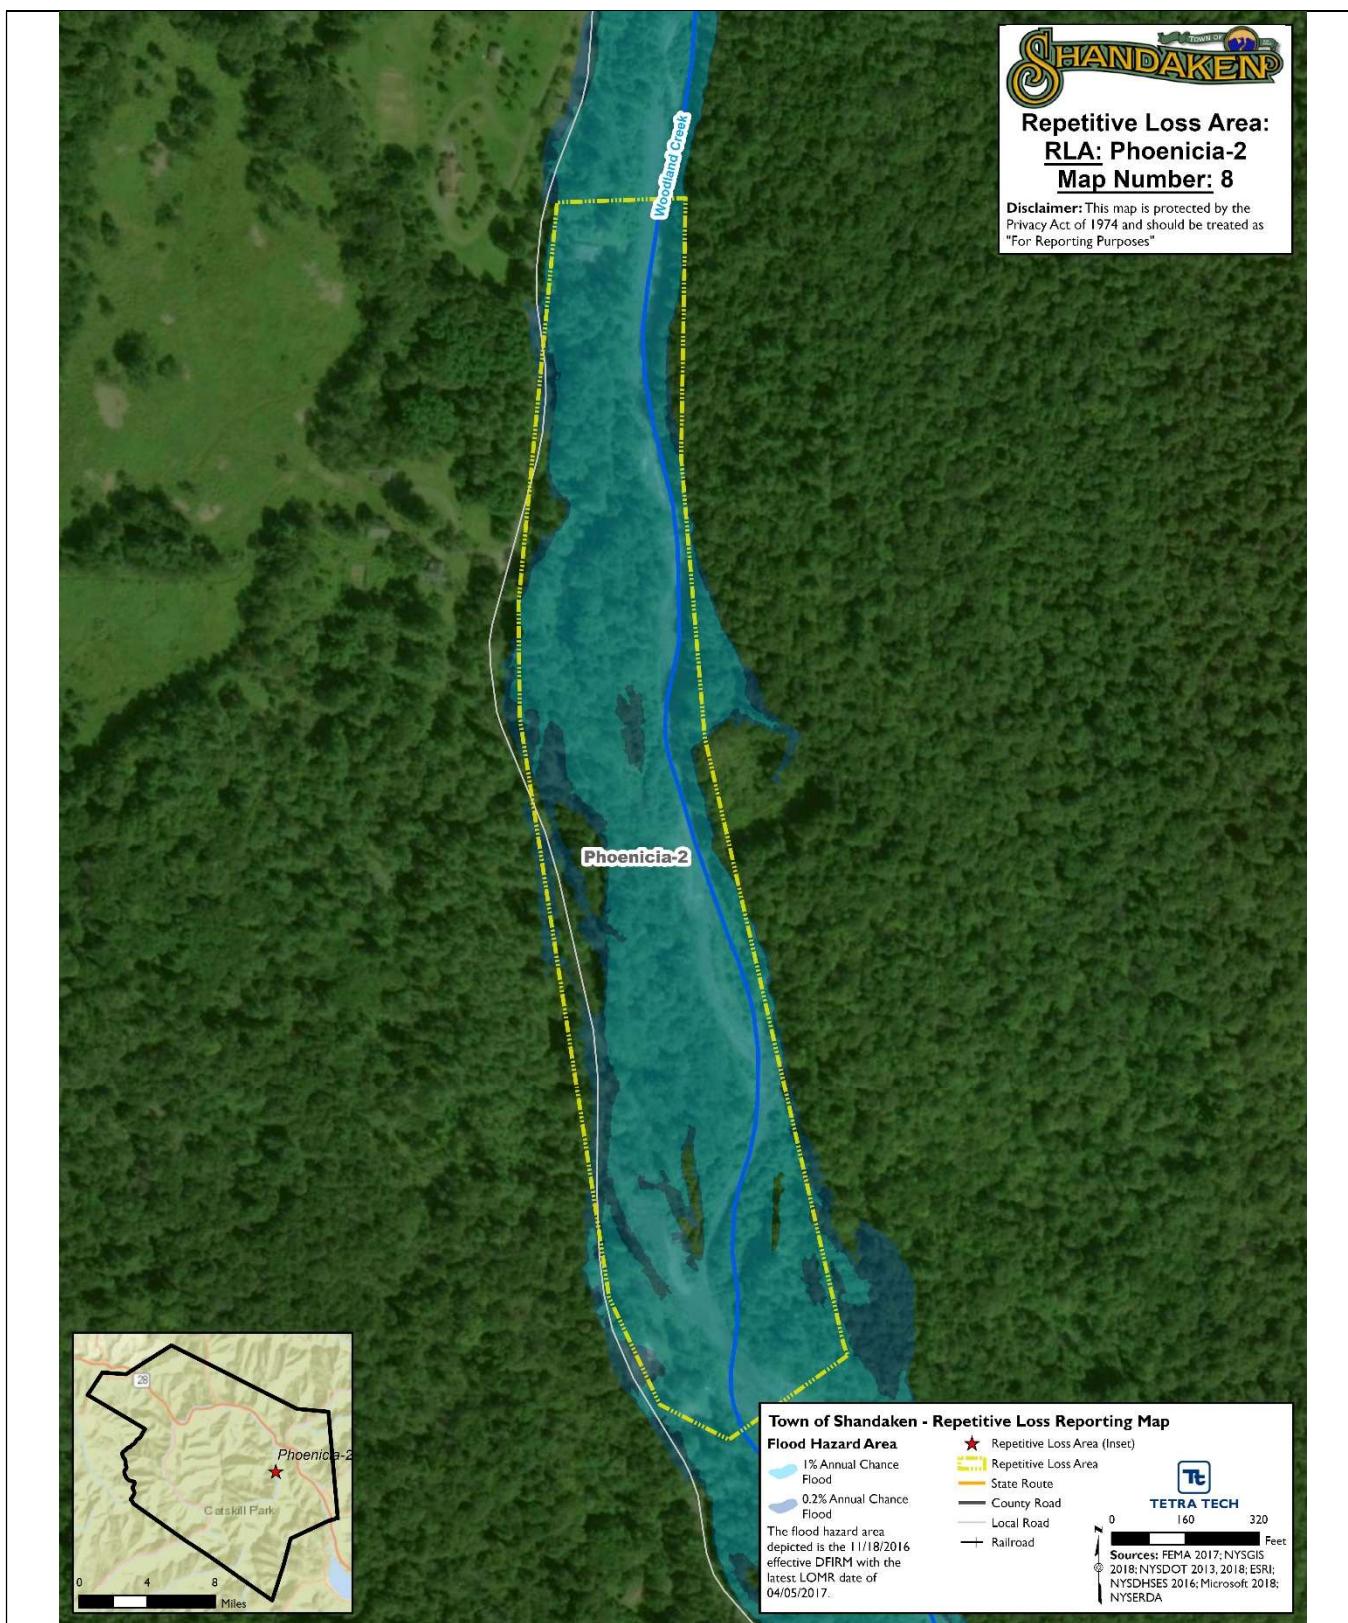
Figure 8-7. Phoenicia-2 Repetitive Loss Area 2025

Property ID	Number of Insurable Buildings	Building Description		Probable Mitigation Measures
		Foundation	Condition	
P-111	1	Crawlspace	Normal	Drainage System Maintenance or Enhancements Acquisition Structural Elevation Elevate Utilities Public education
P-112	1	Slab	Poor	Drainage System Maintenance or Enhancements Acquisition Structural Elevation Elevate Utilities Public education
P-113	1	Slab	Poor	Drainage System Maintenance or Enhancements Acquisition Structural Elevation Elevate Utilities Public education
Total	3

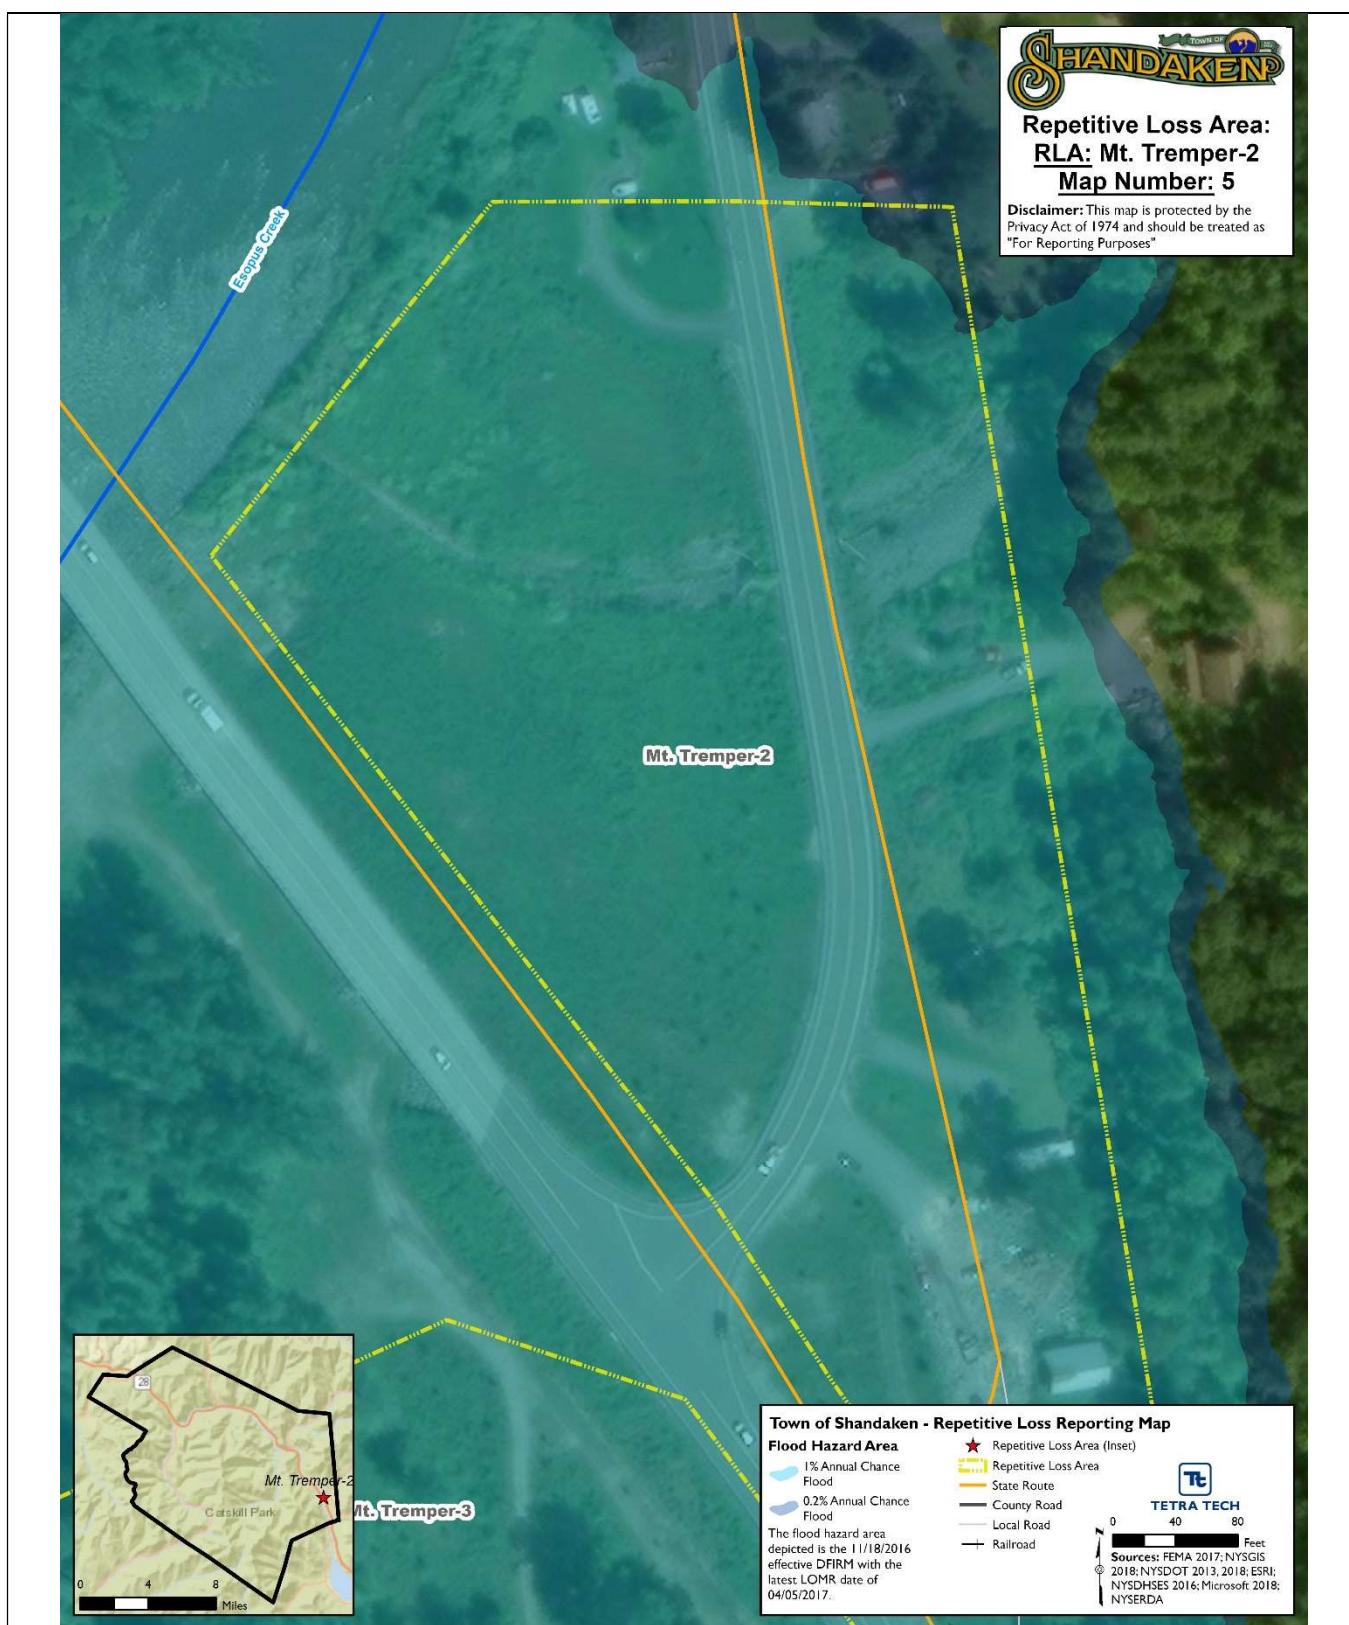
Figure 8-10. Mt. Tremper-2 Repetitive Loss Area – 2025 Retired 2025

Identified Flood Cause: Property is located in the floodplain. Repetitive flooding possibly caused by riverine flooding when storm flows exceed the capacity of the Esopus Creek. No reported losses since 2011. Note: RL # 165236, RL #196089 were not used in the delineation of the area. For 2025 reporting purposes, both RLs in Mt. Tremper-2 were mitigated and the RL area has been retired.
